**MARYLAND HISTORICAL TRUST
DETERMINATION OF ELIGIBILITY FORM**

Property Name: Henry Boothe Farmhouse Inventory Number: SM-459
Address: 46212 Drayden Road (md 237) (MD 244) Historic district: yes ☒ no
City: Drayden Zip Code: 20630 County: Saint Marys
USGS Quadrangle(s): Saint Marys City
Property Owner: Henry and Stanley Boothe Tax Account ID Number: 1902002035
Tax Map Parcel Number(s): 30 Tax Map Number: 62
Project: MD 237 from MD 235 to Pegg Rd Agency: SHA
Agency Prepared By: SHA
Preparer's Name: Kathryn Barrett Date Prepared: 11/26/2007
Documentation is presented in: Maryland Historical Trust
Preparer's Eligibility Recommendation: X Eligibility recommended _____ Eligibility not recommended
Criteria: X A B X C D Considerations: A B C D E F G
Complete if the property is a contributing or non-contributing resource to a NR district/property:
Name of the District/Property: _____
Inventory Number: _____ Eligible: yes Listed: yes
Site visit by MHT Staff yes X no Name: _____ Date: _____

Henry Boothe Farmhouse

Capsule Summary
SM-459
Henry Boothe Farmhouse
Drayden
Private

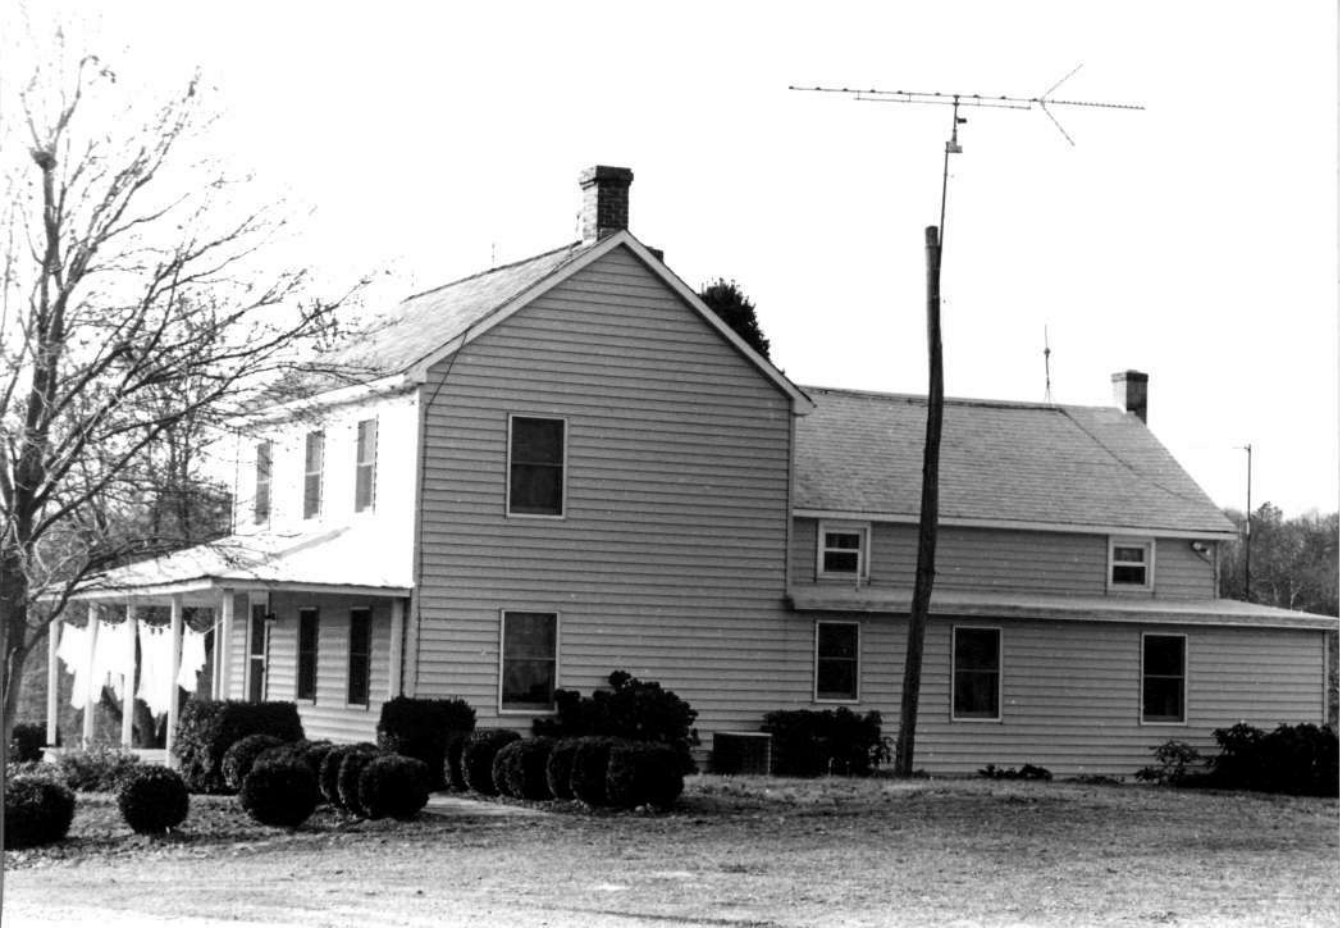
2/5

NE elevation

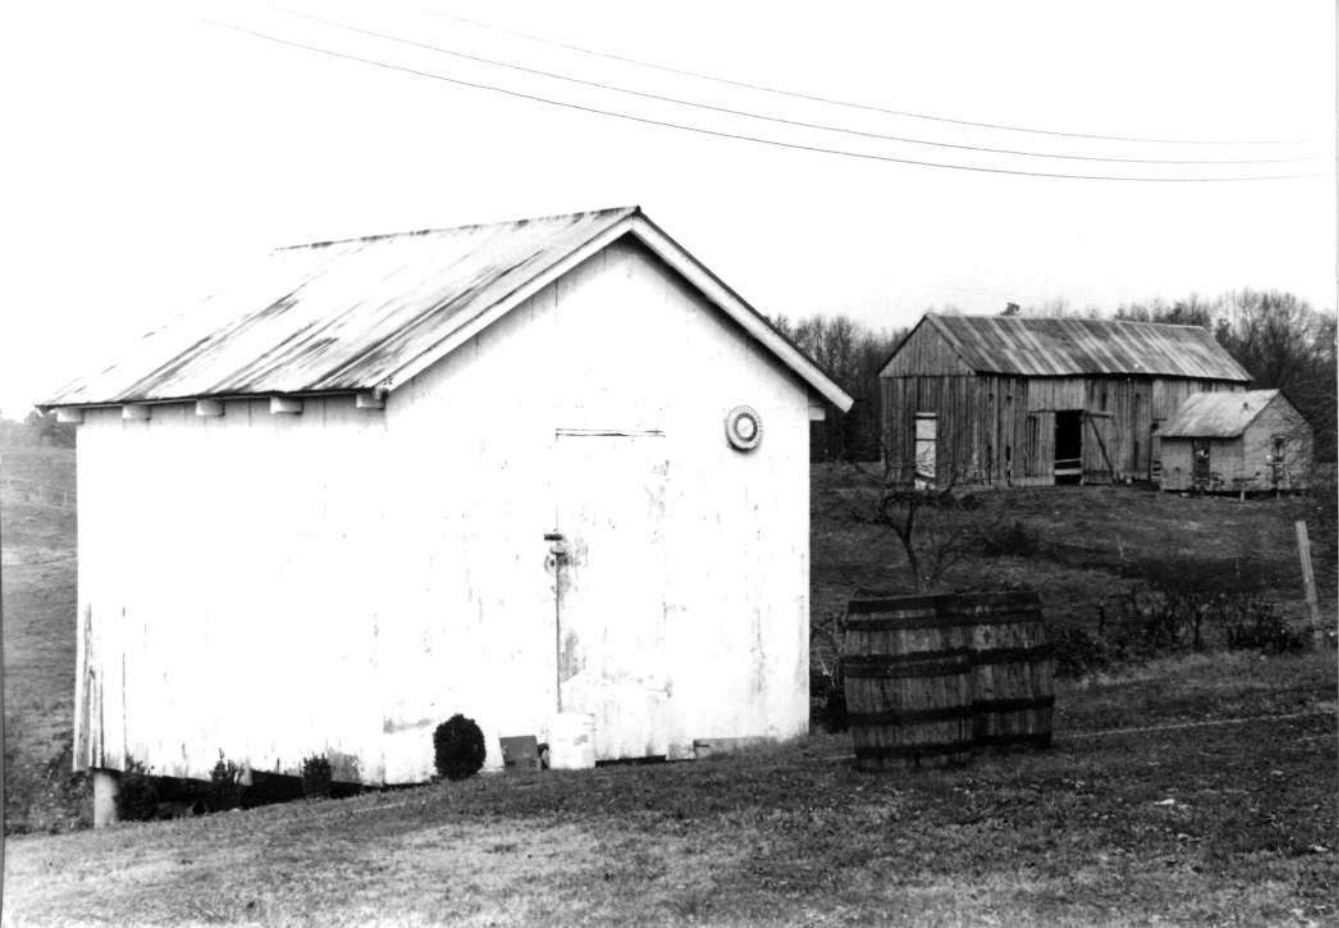
3/5

Meathouse with tobacco barn and strip shed in background.

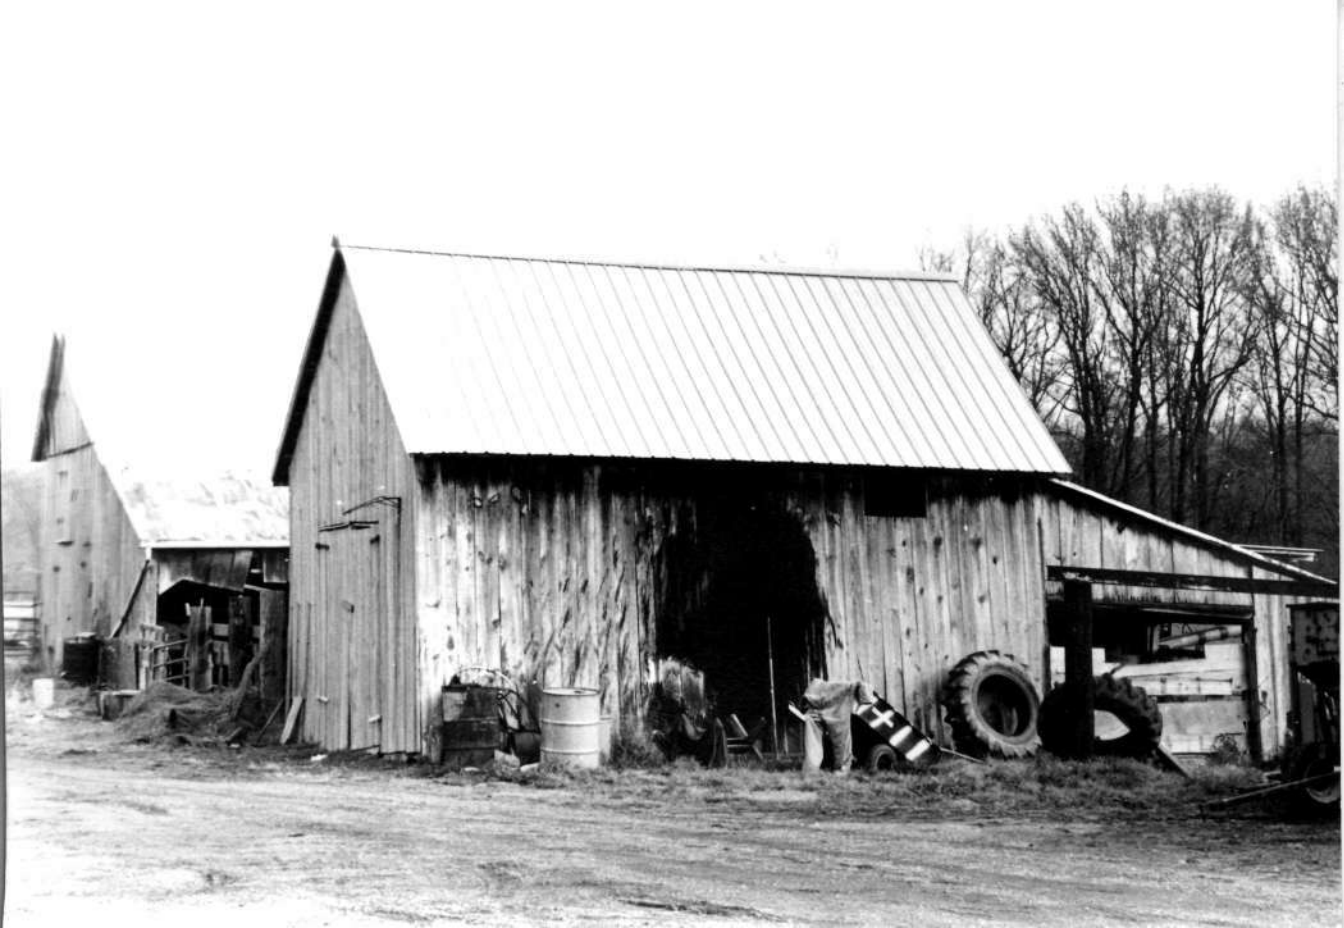
4/5

Granary with tobacco barn in background.
